An Esthetic and Functional Fixed Posterior Space Maintainer-A Case Report

Type of Publication: Case Report

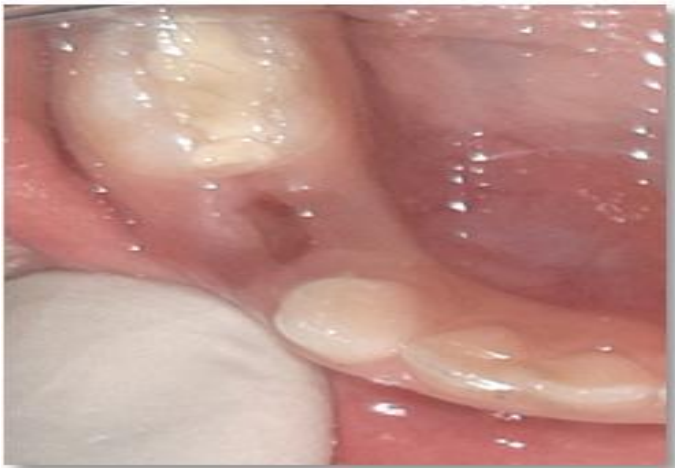
Fig.1: Pre-operative mandibular occlusal views

A 5-year-old girl reported to the Department of Pedodontics and Preventive Dentistry with the chief complaint of missing tooth in the right lower back teeth region. The parents reported with the history of tooth extraction due to grossly decayed 3 days back. On clinical examination it was found that the mandibular right primary first molar was missing and the extraction socket was healed uneventfully (Fig.1).

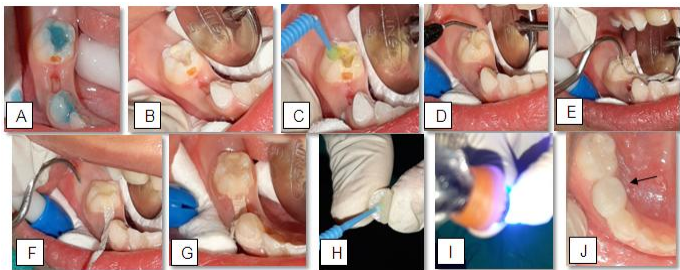
Fig.3: Step by step fabrication of the space maintainer

A. Etched, B. Washed & Dried, C. Bond applied & light cured for 20 sec, D. Flowable Composite filled in the cavity, E. Placement of FRC, F & G. FRC adapted on 83 &85 and light cured for 40 sec, H & I. Bond applied on the inner surface of tooth made up of composite, light cured for 20 sec, and J. finally luted with the help flowable composite in the missing space and light cured completely.

A fixed esthetic functional space maintainer was planned for the replacement of missing first deciduous molar. A strip of FRC resin (Fig. 2A) was cut approximately of the length equal to the distance from the distal surface of class II mesio-occlusal cavity of second deciduous molar to the full circumference of the deciduous canine. The cavosurface margin of the Mesio-occlusal class II cavity and all the surfaces of the canine were etched with 37% phosphoric acid (Fig. 3A). After 15 seconds the teeth were completely washed and dried (Fig. 3B). A white chalky appearance was seen on all the etched surfaces. The bonding agent was applied and cured as per manufacturer's instructions (Fig. 3C). A thin layer of flowable composite was placed over the surfaces of the canine and in the cavity of second deciduous molar following which the FRC strip was adapted (Fig. 3D & 3E). One end of the FRC strip was seated from the base of the cavity in right lower second deciduous molar and the other end was wrapped around the circumference of right lower deciduous canine (Fig. 3F & 3G). Once the strip was placed in position it was cured using a light curing unit. The inner surface of composite tooth made was applied with bond and light cured (Fig. 3H & 3I). Finally, the composite tooth was luted on to the bridge with the help flowable composite in the missing space and light cured completely (Fig. 3J). The occlusion was checked for any premature contact.

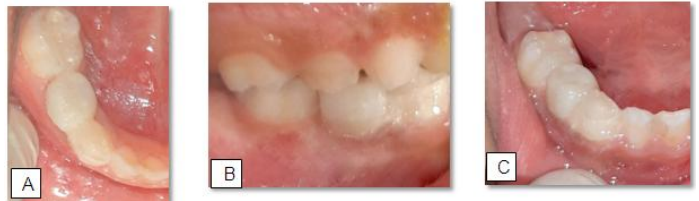
Fig.4: Post-operative view

(A) Occlusal view, (B) Lateral view in occlusion & (C) Follow up Lateral view after 1 week.

The composite tooth was prepared with the help of the rubber base impression of Stainless steel crown chosen according to the appropriate size measured mesio-distally the missing space and then finishing and polishing of the tooth was done (Fig. 2B & 2C). Hence, the desired appliance was fabricated (Fig. 4A). Occlusion was again checked to correct any pre-mature contact if present (Fig. 4B). The patient was recalled after 1 week to check the integrity of the appliance in the mouth Occlusion was again checked to correct any pre-mature contact if present (Fig. 4C). The appliance was found to be satisfactory both functionally as well as esthetically. The patient was kept on 3 months regular recall visits and the appliance was found to be functioning well inside the oral cavity till the last visit (9 months).
