Multidisciplinary Management of a Subgingivally Fractured Tooth: A Case Report

Type of Publication: Case Report

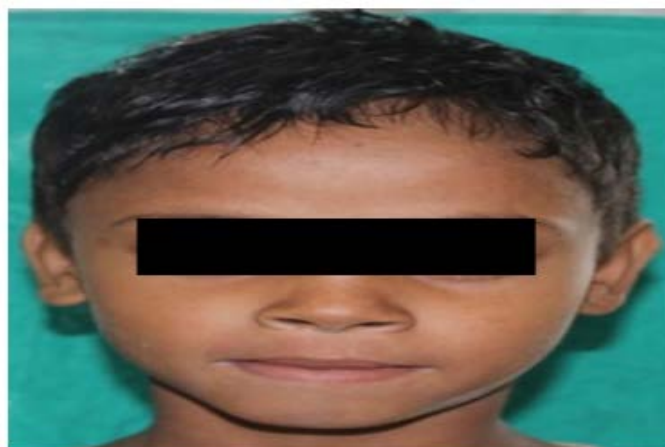
Fig.1a:Extraoral view

A 8-year-old male child resident of Bihar with no contributory medical history reported to the Department of pediatric and preventive dentistry with chief complaint of broken tooth in upper front tooth region. The history revealed trauma 1 month back when he had a fall while sitting on a buffalo which was associated with gingival bleeding. No gross facial asymmetry was reported on extraoral examination.(Fig. 1a).

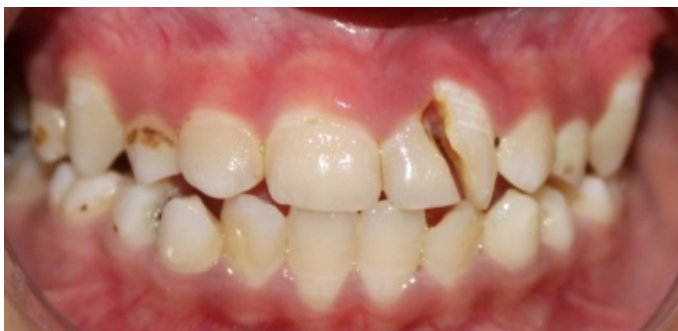
Fig.1b: Intraoral buccal view

The intraoral examination revealed fractured 21 with fractured line extending from incisal edge to passing sub gingivally in the labiopallatal aspect (Fig. 1b), (Fig. 1c). Tooth was tender on percussion, with grade III mobility and only gingival attachment present with respect to fractured mesial fragment. Also, patient was unable to approximate his teeth on biting. Provisional diagnosis of Ellis's class VI fracture wrt 21 was formulated and intra oral periapical radiograph was advised.

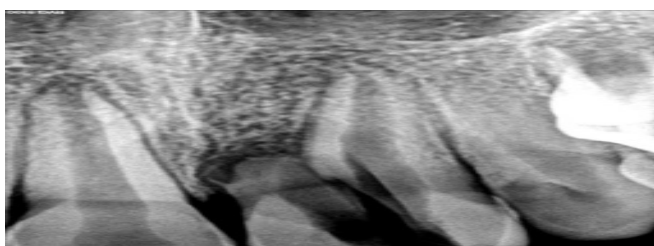
Intra-oral radiograph revealed vertical cleavage line of the traumatised tooth extending from coronal portion to the middle third of the root (approximately 7mm subgingivally) with no apparent periapical pathology (Fig. 2). The apices of the central incisors were nearly completely formed. Clinical and radiographic findings showed no pathological signs in the adjacent teeth.

Fig.2 : Initial RVG showing complicated crown root fracture with 21.

Clinical and radiographic examinations were suggestive of complicated vertical crown root fracture of 21 involving enamel, dentine, pulp and cementum that is Spinus subclass d1 fracture wrt 21. Treatment plan of endodontic therapy with 21 with fibre post and core build up followed by prosthetic rehabilitation was formulated.

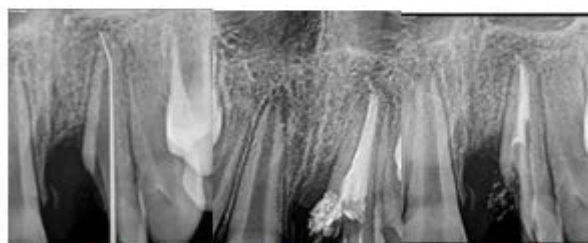
Fig.4 : (a)Working length determination ; (b) Root canal filled with guttapercha ; (c) Post space preparation and fibre post placement

Fractured 21 was anaesthetized with local anaesthetic solution. The coronal tooth fragment (mesial fragment) was detached and the extent of trauma was further investigated (Fig. 3a). Due to sub gingivally extending fracture line and overgrowth of tissue in the fragment area, achieving isolation was a great challenge. The pulpal tissue from the root canal was extirpated with barbed broach (Fig. 3b) and the canal was irrigated with physiological saline and dried with paper point. Electrocauterisation of the gingival growth was carried out following pulp extirpation (Fig. 3c). A size 20 K file was used to estimate the working length (18mm), from the incisal edge (Fig. 4a). The canal was prepared using crown down technique with K files up to the size 45. The canal was irrigated with physiological saline and dried with paper points. Gutta percha points were inserted into the prepared canal and the canal was obturated (Fig. 4b). Subsequently post space preparation was done until an apical 5mm of gutta percha was retained using peso reamer No.3. Fibre post No.3 was selected, inserted through the post space, and luted using flowable composite (Fig. 4c). Fractured segment was built up using band material and flowable composite resin (Fig. 5)

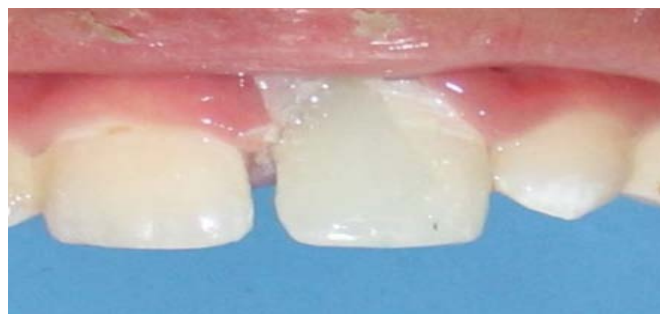
Fig. 5: Composite build up with 21

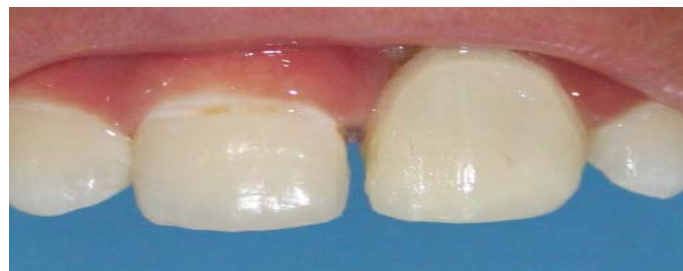
Figure 6: Polycarbonate crown placement

followed by prosthetic rehabilitation with polycarbonate crown (Fig. 6). Occlusion was evaluated (Fig. 7). Post-operative instructions were given to the patient and the patient was recalled after 15 days for evaluation. Clinical and radiographic examinations carried out after 1 month, 3 months and 6 months confirmed the satisfactory aesthetic and functional outcome of the treatment with no associated endodontic or periodontal problem (Fig. 8,9).

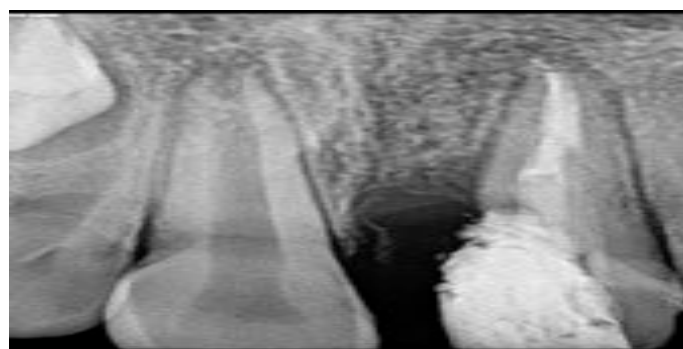
Figure 7 : Check radiograph after composite restoration
