**Core Build Up and Layered Zirconia Restoration on Fractured Central Incisor – A Case Report**

**Type of Publication:** Case Report

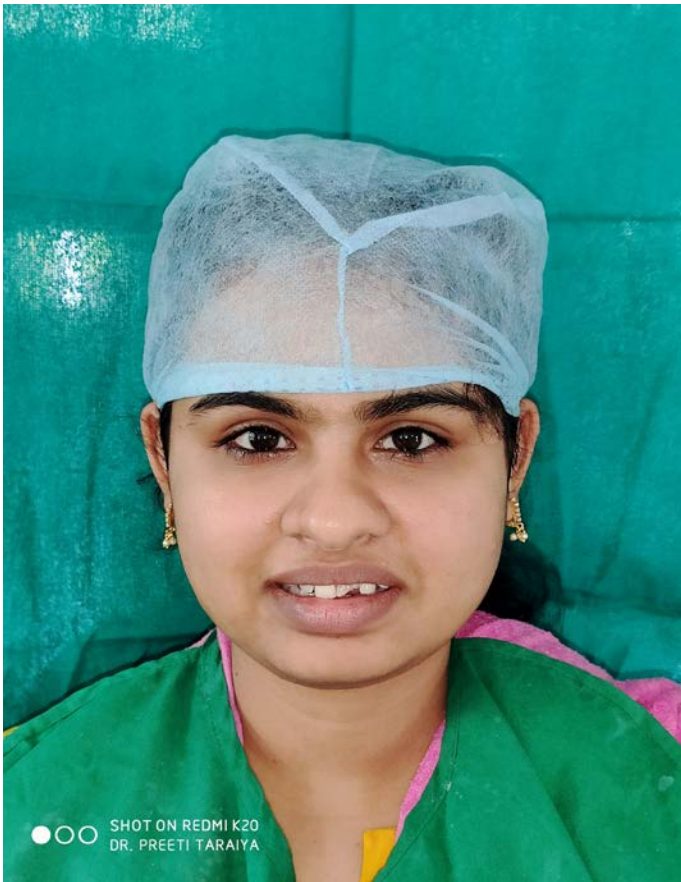
Figure 1: preoperative view

A 28-year-old female patient reported to the department of Prosthodontics and Crown and Bridge. Her chief complaint was broken front teeth. Intraoral examination revealed Ellis class III fracture and discoloured left central incisor (21). Fractured tooth was non vital and rest all teeth were vital. No medical history was present. History of trauma, due to accident 10 years ago. Dental history revealed RCT (root canal treatment) done 10 years ago and no prosthesis since then. Figure 1 represents preoperative view.

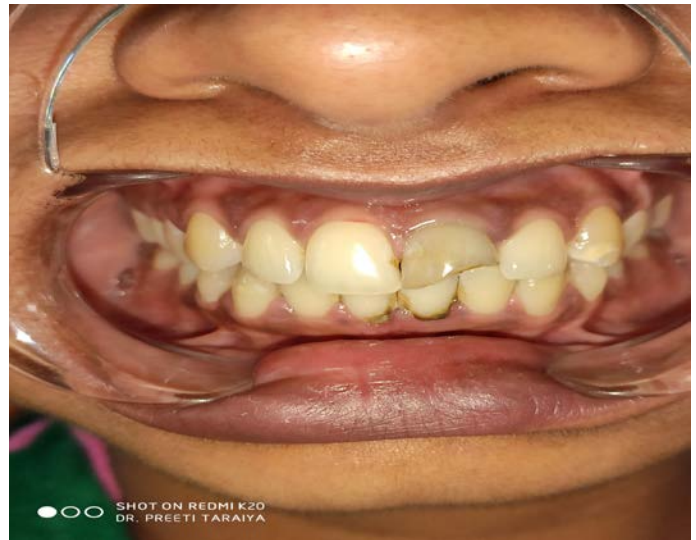
Figure 2: intraoral view

After the clinical examination (figure 2), diagnostic impression was taken and poured in class IV stone to fabricate study casts. Facebow was recorded (figure 3) and maxillary and mandibular casts were mounted on semi adjustable articulator. (figure 4) Mock-up was done to evaluate the final treatment outcome and was showed to the patient. (figure 5) On approval of the patient, we proceeded with further steps. As the height of the teeth was compromised due to extent of the fracture till middle third of the tooth, the crown structure left was insufficient for retention of the crown. Therefore, composite core build-up of the tooth was done. (figure 6).

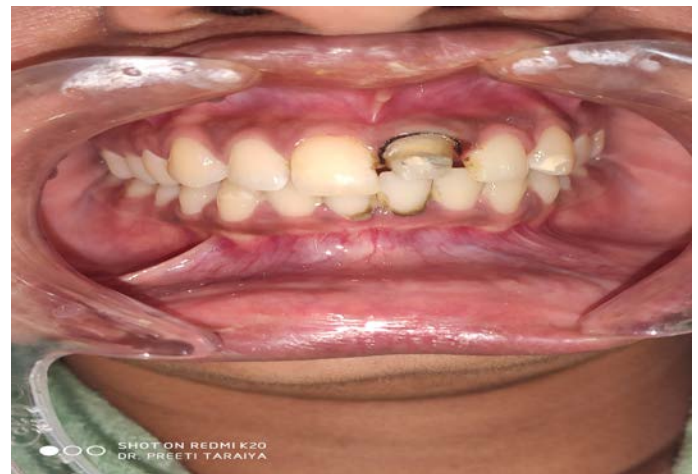
Figure 7: Gingival retraction

The tooth was then prepared with 1.2 – 1.5 mm axial reduction and 1.5 – 2 mm incisal reduction and 6 – 15-degree taper. Occlusal reduction was checked with fleximeter strip. All the line and point angles were rounded off. A chamfer finish line was prepared circumferentially. Retraction cord of size # 00 was placed in the gingiva to record finish line properly in the final impression. (figure 7) Final impression was made using C-silicon impression material with double stage impression technique. (figure 8) Shade matching was done with VITA shade guide. (figure 9) The cast was poured in type IV stone. Provisional crown was fabricated using autopolymerising acrylic resin. Cementation of provisional crown was done with templute (temporary luting cement). (figure 10) The stone cast was scanned in CAD CAM Scanner (Amann Girrback Ceramill Map Scanner). The restoration was designed in CAD software (Amann Girrback CAD Ceramill mind software) and milled in CAM unit (Amann Girrback CAD Ceramill Matrix unit). (figure 11)
