Accidental Ingestion of Nance Palatal Archwire in COVID 19 lockdown

Type of Publication: Case Report

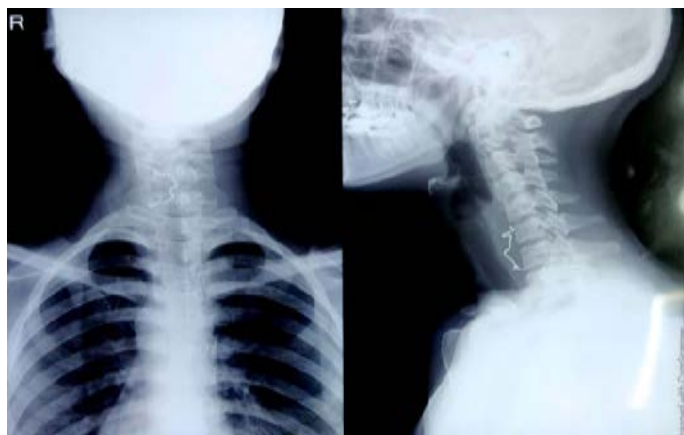
Fig 1: A-Posteroanterior view of neck shows wire component at the level of C6 and C7; B-Lateral view of neck shows wire component at the level of C6 and C7.

Questionnaire and consent for screening patients with the potential risk of infection of COVID-19 as per guideline before any intervention. Under the proper guideline of the COVID-19 outbreak, a radiograph of the frontal and lateral view of the neck was taken to localize the object (**Fig.1**). The radiographs showed vertical impaction of palatal archwire anterior to C6 and C7 level in the upper oesophageal region. Since the patient had no side effect of injury or perforation, a preservationist approach was liked to perform in the conference with a gastroenterologist, to recover the wire component by endoscopy. At endoscopy, it was found to be in the upper part of the esophagus. By utilizing endoscopic grasper, the wire component was grasped, delicately pulling it out of the upper oesophageal

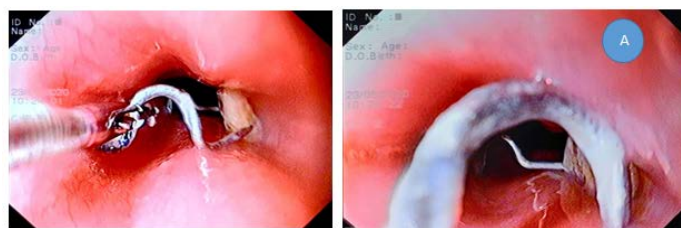
Fig 2: A-Endoscopy confirmed that the wire component with acrylic button was lodged in upper part of esophagus; B-Removal of appliance with the help of endoscopic grasper.

area along with endoscope (**Fig.2**). The intraoral band or attachment was thoroughly examined with the recovered wire component for any missing part (**Fig.3**), intraorally we found a band of the right upper first molar was loose, cementation of the band was done, and then the patient was sent to the home with proper instruction of three days home quarantine. These procedures were performed with the proper guideline issued to the handling of these patients. Her sample for the COVID 19 virus testing was done as precautionary measures by experts.

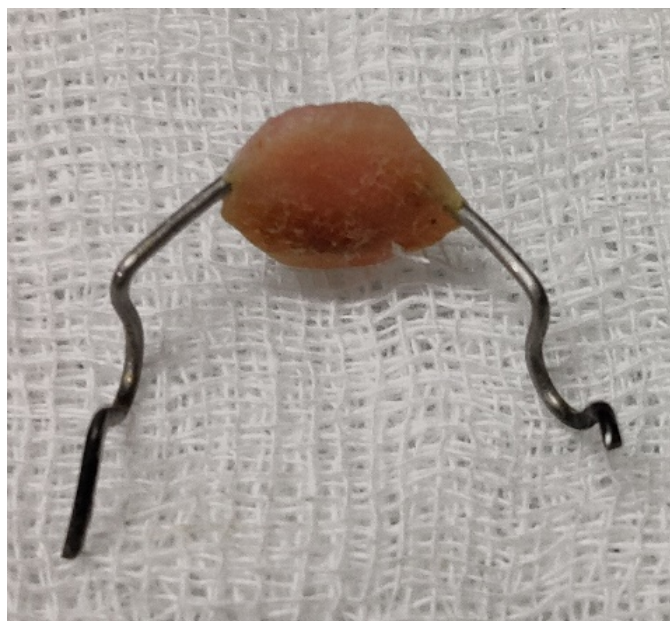
Fig 3: Retrieved Nance palatal arch with wire component and acrylic button.
