**Localized peri-implantitis management around auricular implant followed by fabrication of silicone prosthesis in patient of congenital bilateral microtia**

**Type of Publication:** Case Report

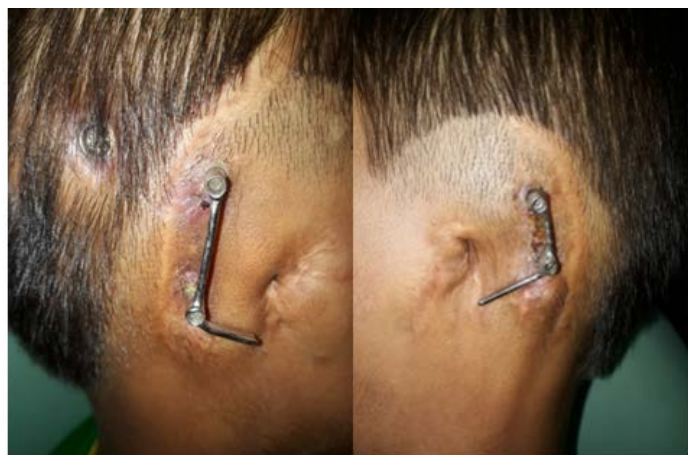
Figure 1: Showing red, moistened soft tissue along with epithelial crust deposited around implant abutment interface.

Patient's parents had given history of recurrent infection around external auricular implants and patient had undergone medication for this from time to time. Upon clinical examination, there was mild bleeding or pus discharge and accumulation of crustings around both implants. The soft tissue reaction was graded as Holgers grade III i.e., redness, moistness, and moderate swelling with tissue granulation around the abutment. The cotton swab was taken from pus discharged around implant abutment and sent to the microbiology lab for culture and sensitivity test (Figure 3.). The peri-implantitis was managed locally by daily cleaning the tissues around implants according to the methods followed by Rokaya et al. 2013.<sup>4</sup> The soft tissue crusting was removed using soft nylon (interdental) brush and instructed to the patient for the same. The implant abutments and Hader bar was

cleaned using hydrogen peroxide (1:1 diluted with normal saline) and with betadine. Patient was also instructed that hairs should not be grown around implant. Hairs should be trimmed if it becomes long as it can wrap around the abutment and can provoke an inflammatory reaction.

In this case report, the major soft tissue problems around implants (erythema with granulation formation, infection-Hoglers grade III peri-implantitis) was due to poor hygiene. It was managed locally by cleaning with diluted hydrogen peroxide, betadine, curettage and regular

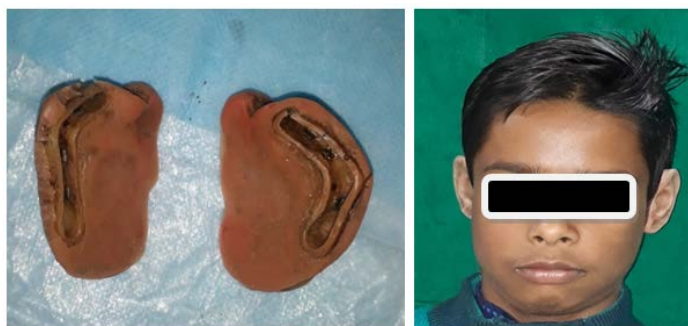
Figure 2: (a) Old silicone prosthesis with acrylic housing (b) Patient with old silicone prosthesis.

Past surgical history- Recanalisation for external auditory meatus 7 years back and underwent BAHA (BONE-Anchored Hearing Aid) 6 years back to restore the normal sound conducting mechanism. On X-ray skull AP/ both lateral view (7 years back)- sclerotic & acellular bilateral mastoids were found. Bilateral external auditory meatus were not visualised (hypoplastic or atretic). Patient had undergone bilateral implantation (Southern implants with customised bar superstructure) for retention of ear prosthesis 5 years back (Figure 2.).

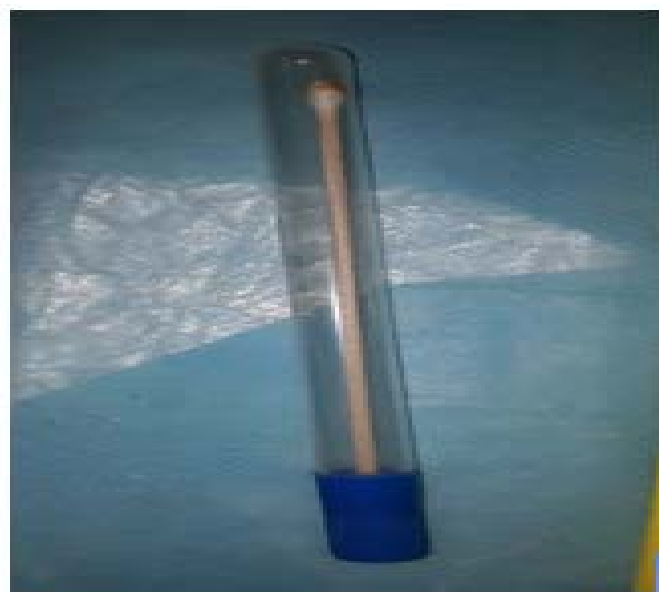
Figure 3: Cotton swab was taken for culture sensitivity test.

Results of culture sensitivity test reported, Staphylococcus aureus as main pathogen and drug resistance to Penicillin group, Erythromycin, Trimethoprim and Sulfamethoxazole. The isolated organism was sensitive to Clindamycin and all  $\beta$ -Lactam antibiotics except Penicillin. Patient was referred to ENT Department for the further management. Patient was under medication for one and a half month. Initially, narrow spectrum antibiotic was started (Tab Clindamycin 300mg BD X 6days) along with anti-inflammatory (Tab Diclofenac 50mg in combination with Trypsin and Rutoside). When infection was not subsided, antibiotic regimen was shifted to moderate spectrum (Tab Clarithromycin 500mg OD X 5days along with Tab Metronidazole 400mg TDS X 5days, Hydroheal Ointment X15 days and Inj Gentamicin 80mg).

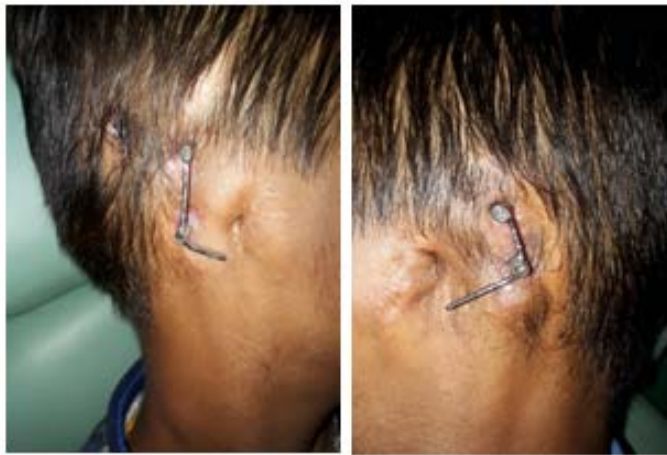
Figure 4: After management of peri-implantitis.

When peri-implantitis was subsided with Holgers Grade 0: reaction free skin, fabrication of new prosthesis was initiated. (Figure 4) The patient was strictly advised for hygiene maintenance of the implants.

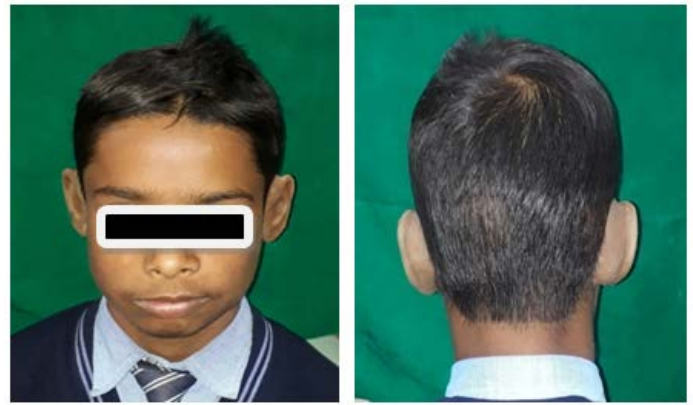
Figure 8: (a) & (b) Patient with bilateral auricular silicone prosthesis.

The room temperature vulcanizing (RTV) silicone (MP Sai, Enterprise) was used for the fabrication of the final prosthesis provided with intrinsic stains for shade matching as it was economical to the patient. Basic colors used were yellow, white, brown, purple, and red. The stains were added to the silicone paste for optimal color match. Constant comparison was done with the skin of the approximate area. The flasks were kept for 24 hours at room temperature as per the manufacturer's instructions for complete vulcanisation. After complete processing of silicone, it was removed from the mould (Figure 7.). Examination of the final prosthesis was done for any defects and porosities. Excess flash was cut with sharp scissor and cut ends finished with fiber trimming wheels using straight handpiece. The final prosthesis was then tried on the patient and aesthetically acceptable to the

patient (Figure 8.). Patient was instructed to clean daily the area around implant supported bar to remove any soft tissue debris and dried exudates accumulated around abutment by using a soft end nylon bristle interproximal dental brush, or a cotton swab. The patient was also instructed to be careful while removing the prosthesis so that the thin margins do not tear and the silicone rubber does not separate from the acrylic housing. The patient was also instructed to remove his prosthesis at night for aeration of the implant area and to avoid humidity underneath the prosthesis which may cause local irritation. This is more important in hot weather due to more humidity as patients had more problems during this season as described earlier.

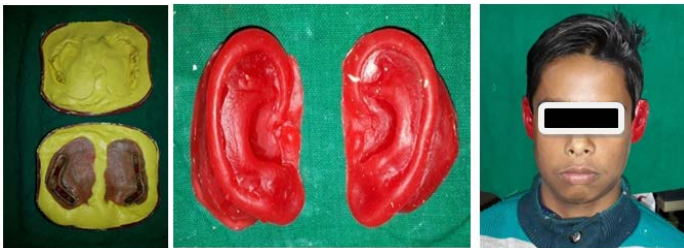
Figure 6: (a) Bilateral mould of ear was formed by duplicating old auricular prosthesis in irreversible hydrocolloid (b) Mould with acrylic housing in place was poured with molten wax (c) Wax prosthesis trial done.

material. After the impression had set, impression was removed, using a slight twist to facilitate removal (Figure 5.) Stone cast was poured from the impression which was used as a guide to obtain the wax pattern. Bilateral impression of the old ear prosthesis was also duplicated by using irreversible hydrocolloid impression material in duplicator and wax patterns were obtained along with old acrylic housing having bar clip attachments. The wax prosthesis then tried on the patient and evaluated for the accurate fit on the tissues, correct horizontal bilateral alignment with the contralateral side, orientation of the ear in relation to the side of the head and integrity of the margins during simple jaw movements was checked (Figure 6.). The wax pattern was invested in the denture flask to obtain the mould. Mould was obtained in three parts to achieve easy placement of silicone. The wax prosthesis was sealed to the model. Locations were cut in the helix area of the mould to orient the second piece of the mould around the helix accurately. Above this third piece of mould was placed.
