Retrieval of the displaced implant from maxillary sinus – A case report

Type of Publication: Case Report

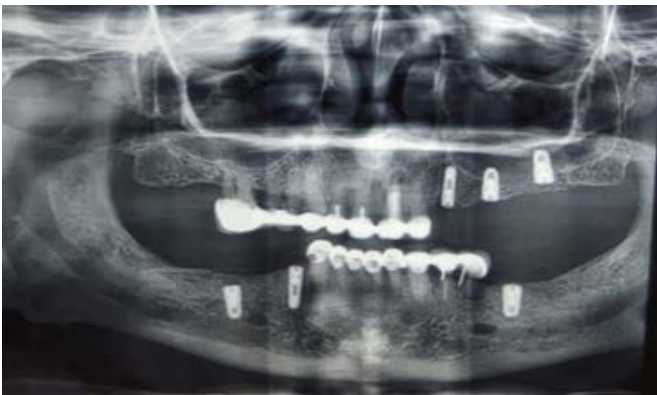
Fig 1 – a: Dental implant placed in the region of 23, 25 and 27.

A 70 year male patient was referred to the department of Oral and Maxillofacial Surgery of Dasmesh Institute of Dental Sciences and Research, Faridkot, Punjab with the chief complaint of pain in the region of maxillary second quadrant since 1 month. According to the history given by the patient, he had undergone implant placement in the maxillary left anterior and posterior region 8 months back {Figure 1 (a)}. 8 months after the surgery, the patient reported of pain in the sinus region.

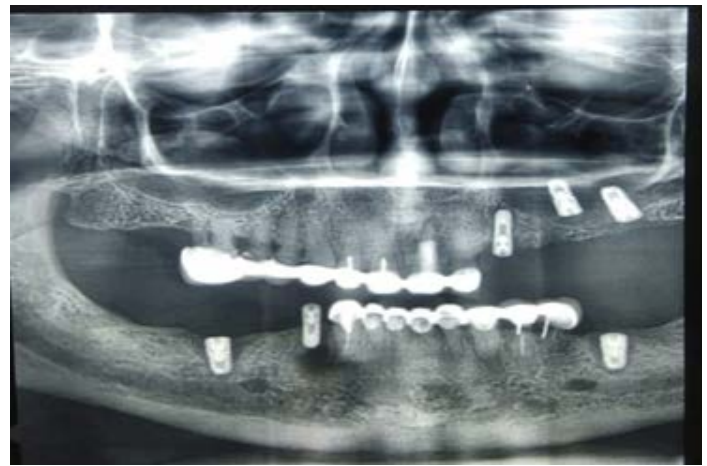
Fig 1 – b: Situation of implants after 3 months.

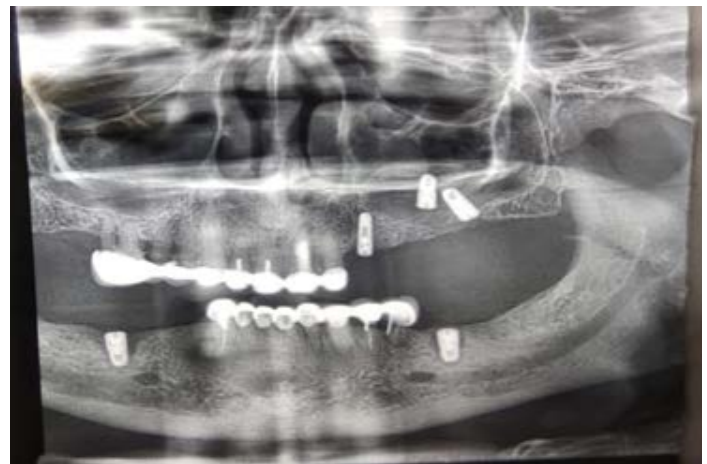
Fig 1 – c: Situation of implants after 6 months.

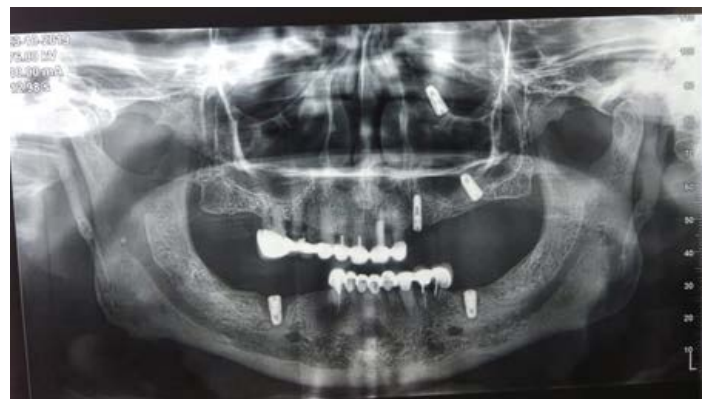
Fig 1 – d: Displaced implants seen in the region of 25 and 27. The implant in the region of 27 was seen lying on the floor of the sinus wall, whereas the implant placed in the region of 25 was seen lying at the level of lateral wall of nose, at the level of ostiomeatal complex

On panoramic radiograph, dental implant displaced in the region of 25 and 27 were seen. The implant placed in the

region of 27 was seen lying on the floor of the sinus wall, whereas the implant placed in the region of 25 was seen lying at the level of lateral wall of nose, at the level of ostiomeatal complex {Figure 1 (b) – 1 (d)}.

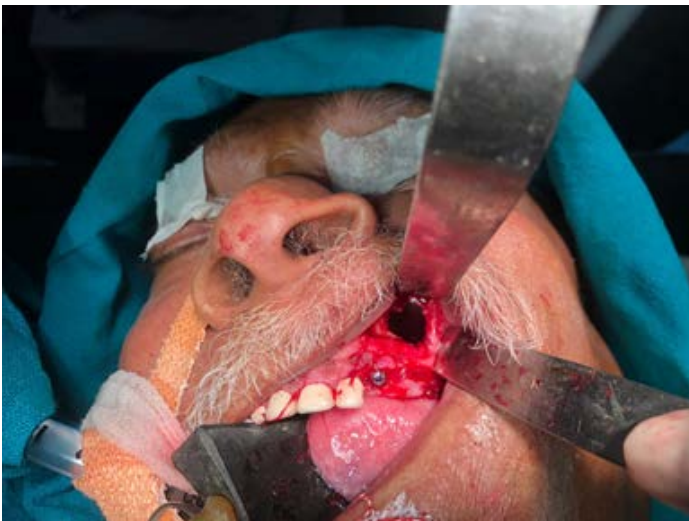
Fig 2: Clinical photograph showing membrane perforation through the left bone window to gain full access into the sinus cavity.

Surgical Protocol - The patient was operated under general anaesthesia. Patient consent was taken prior to surgery. The surgical approach planned was the Caldwell-Luc procedure. Crestal incision and release incision was given in 2nd quadrant in the region of 25 and 27. Trapezoidal full-thickness mucoperiosteal flap was raised. (Figure 2). Anterior maxillary sinus bony wall was exposed. A low-speed straight hand piece with round diamond bur was used to perform spherical osteotomy. Schneiderian membrane was perforated through the bone window and full access into the sinus cavity was achieved (Figure 2). Sinus cavity was irrigated with sterile saline and the implants were identified which were removed with a long mosquito artery forcep. The surgical flap was approximated and sutured back using 3-0 mersilk to close the surgical defect. After extubations, patient was shifted to ward and discharged next day. Patient was prescribed oral antibiotics and anti-inflammatory therapy drug every 8h and nasal decongestants for 7 days. The postoperative recovery was uneventful and sutures were removed after 7 days.

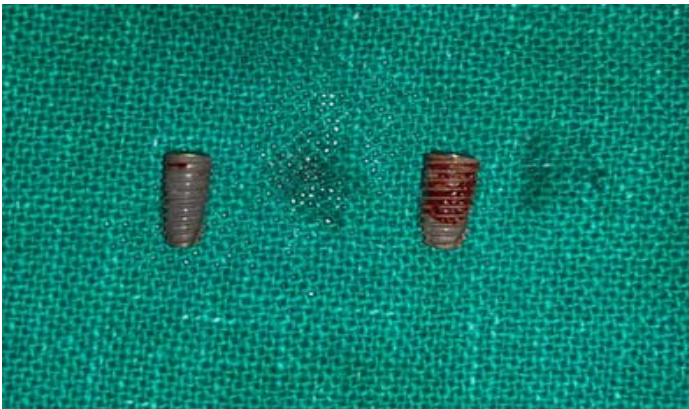
Fig 3: Picture showing the displaced implant after removal.
