**Accidental ingestion of healing abutment during follow up period after second stage surgery of implant placement**

**- A case report**

**Type of Publication:** Case Report

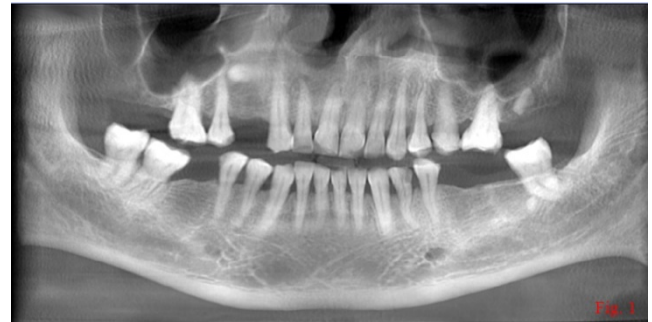
Figure 1: Orthopantomograph showing impacted first premolar at apex and root stump at 27.

Intraoral examination showed missing teeth in relation to 14, 17, 18, 27, 28 and 36, 37, 38,47,48 regions of upper and lower arch respectively. The remaining teeth present appeared attrited. His dental records included a previously taken OPG that revealed horizontally impacted maxillary

first premolar at the apical region and a root stump in 27 regions. Lower teeth showed mild horizontal bone loss [Fig 1]. As a part of implant protocol a CBCT was advised which revealed thick buccal and lingual cortices in the edentulous area with coarse trabeculae in the cancellous portion suggesting suitability for implant placement. [Fig.2]

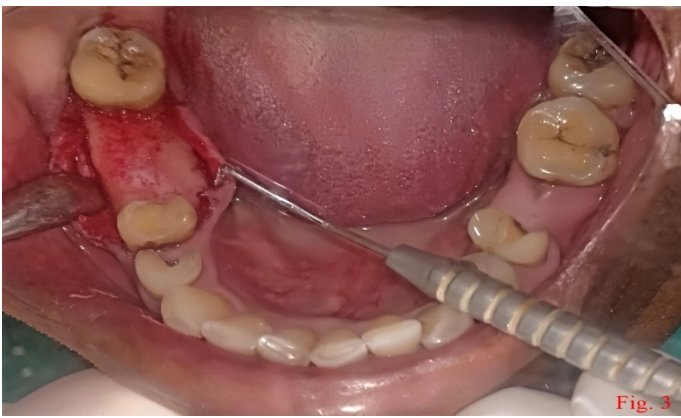
Figure 3: Clinical view of full thickness flap elevation.

Following the protocol of two stage implant placement surgery, a full thickness flap was elevated. [Fig. 3] Two implants of size 4.5x11mm sized were placed in 36 and 37 region and covered with cover screws followed by flap closure. A radiograph was advised which showed the placement of implants with the cover screws in place. [Fig 4]. The patient was rescheduled for follow up after 4 months for second stage surgery following which, the cover screws were retrieved and healing abutments placed. Again a radiograph was advised, which showed placement of healing abutments [Fig.5]. The patient was appointed two weeks later for ensuing the prosthetic phase. This two weeks' time period was given for the soft tissues to remodel and form emergence profile. As the patient returned for the prosthetic phase and was examined orally, to our dismay, there appeared a missing healing abutment from 36 region. On enquiry the patient expressed his unawareness regarding it and neither remembered of swallowing or spitting it. On further enquiry the patient denied symptoms such as stomach discomfort, pain, fever, nausea, vomiting, melena, etc. A physician was consulted in this regard who advised an anteroposterior abdominal radiograph which revealed the location of the healing abutment in the ascending colon region of large intestine which appeared radioopaque [Fig.6]. Further the patient was advised to consume fibre rich food, for easy peristalsis, aiding in mobility of the instrument and to repeat the radiograph after a week. The second radiograph taken after a week revealed the absence of the

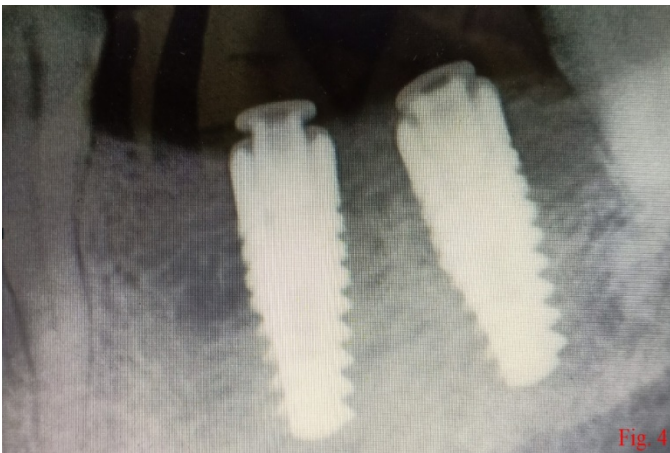
Figure 4: Radiographic view of implants with cover screw in place.

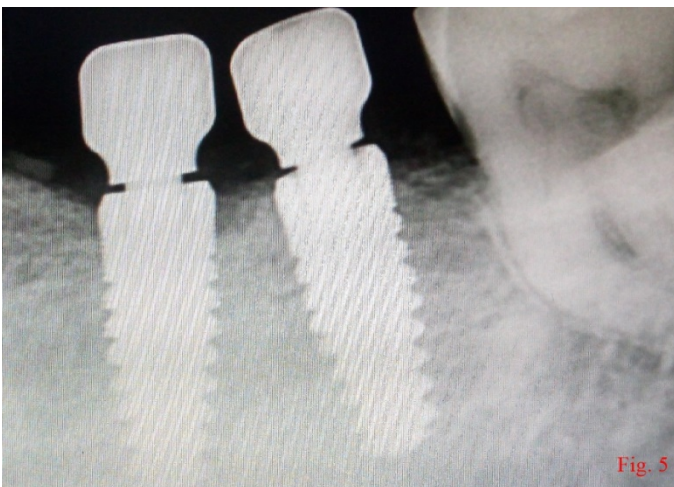
Figure 5: Radiographic view of healing abutments in place.

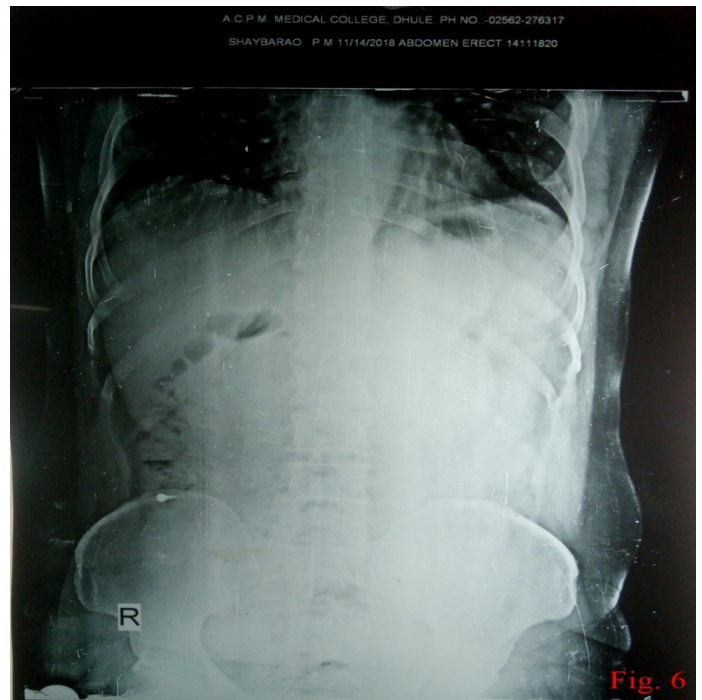
Figure 6: Anteroposterior radiograph showing location of healing abutment in ascending colon of large intestine.

Localization of the foreign body is of utmost importance once it's lost. If aspirated, it can be found in throat or cervical area, then it can be retrieved carefully, with a blunt tipped long forceps or the patient can be asked to cough forcibly. If the instrument is found deep into the larynx, trachea or bronchus, then management through bronchoscopy remains the treatment of choice [4] . If the object is located in esophagus it needs be retrieved with Foleys catheter or endoscope.[5]. It is also said that instruments entering the GI tract usually pass asymptotically and a traumatically within 2 days to 4 weeks and only 1 percent of ingested foreign bodies cause intestinal obstruction requiring surgery [6]. In ingestion cases, the site of involvement is related with the time after the accident, likewise, if the checking time is short, the object is likely to be in stomach ;otherwise it will be in the intestine [2] . In the present case, as the checking time was of two weeks duration, the instrument had surpassed

stomach and was found in the ascending colon of large intestine.

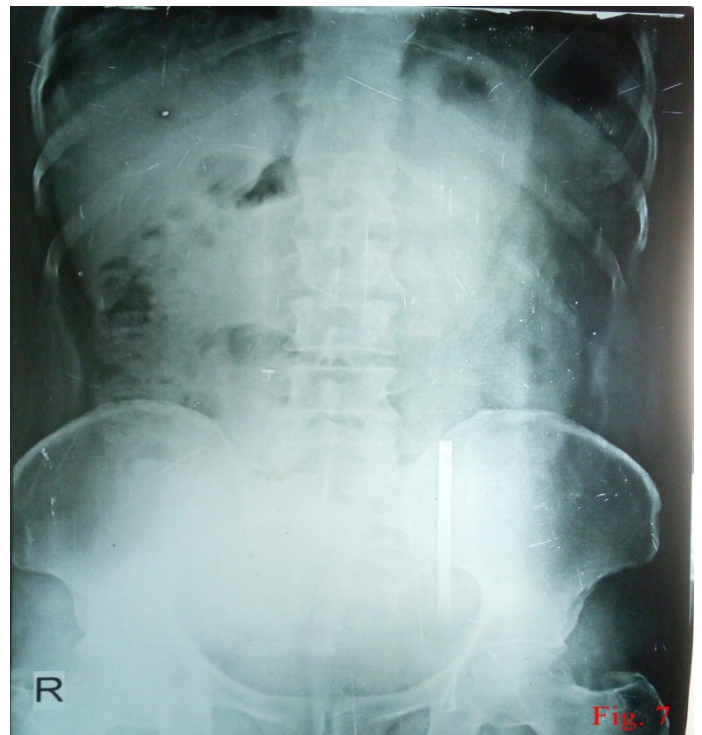
Figure 7: Anteroposterior radiograph showing absence of healing abutment from the colon.

healing abutment suggesting its elimination from the abdominal cavity. [Fig.7]. At this juncture, the patient appeared relieved and reassured. After a week the patient was appointed for the prosthetic phase of the implant protocol which was completed in a month [Fig.8].

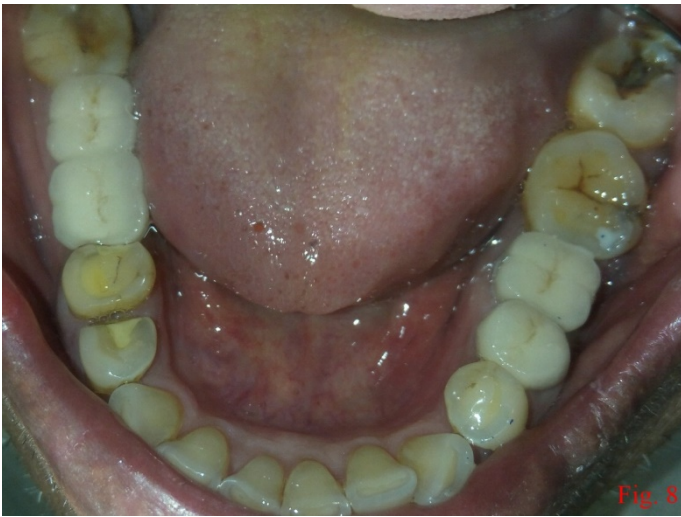
Figure 8: Clinical view of completed implant prosthesis.
