**Management of fractured anterior tooth using novel fiber post by minimally invasive method**

**Type of Publication:** Case Report

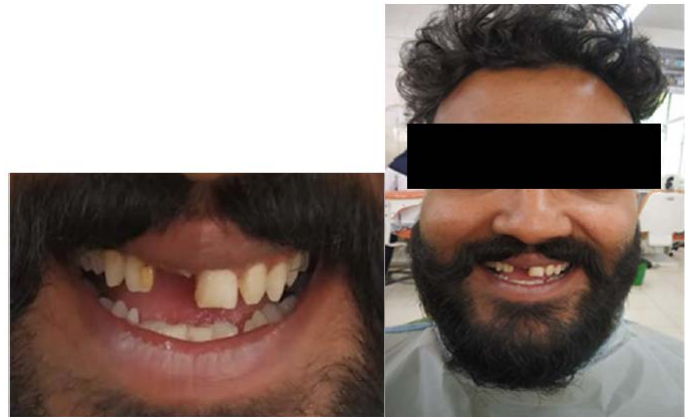
Figure 1: Preoperative photograph

A 30-year-old male patient reported to Department of Conservative dentistry & Endodontics, DAPMRV Dental College, Bengaluru with the chief complaint of a fracture of his maxillary right central incisor due to road traffic accident. History of trauma: patient gives history of fractured tooth [Figure 1] 1 year ago due to road traffic accident and no treatment was done. Patient presented with severe, continuous, localised pain in upper front tooth region. The Medical history was non-contributory. Intraoral examination revealed maxillary right central incisor with a complex fracture and an intraoral sinus tract opening. Radiographic examination revealed complete root end development of the tooth and radiograph showed chronic periapical abscess and remaining crown structure was 1 to 1.5mm. Considering the clinical situation, treatment plan was to institute endodontic treatment of maxillary right central incisor and post endodontic treatment with a novel fibre post [Figure 2] by minimally invasive method using bio light

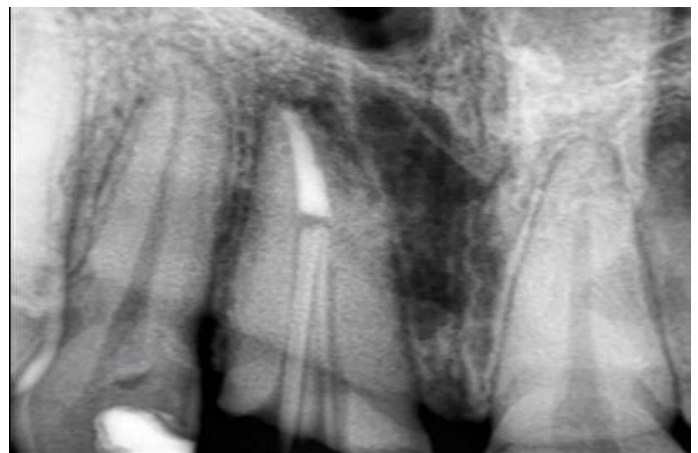
Figure 2: Selection of biolight plus fiber bundle

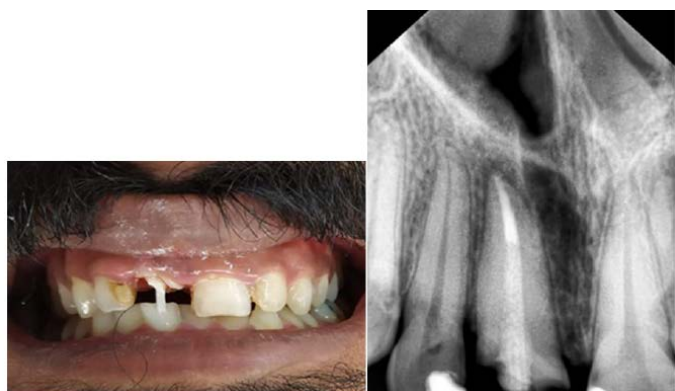
Figure 3: Cementation of biolight plus fiber post

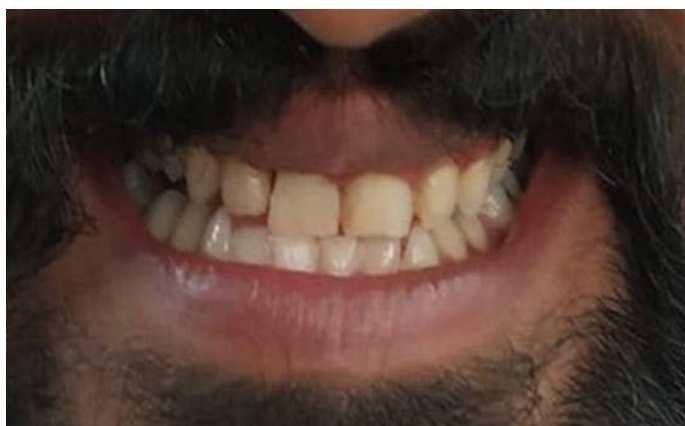
Figure 4: Core build up using composite resin (ivoclar vivadent composite resin)

of crowns in occlusion, it was luted using dual cure resin cement [Figure 4 and 5].

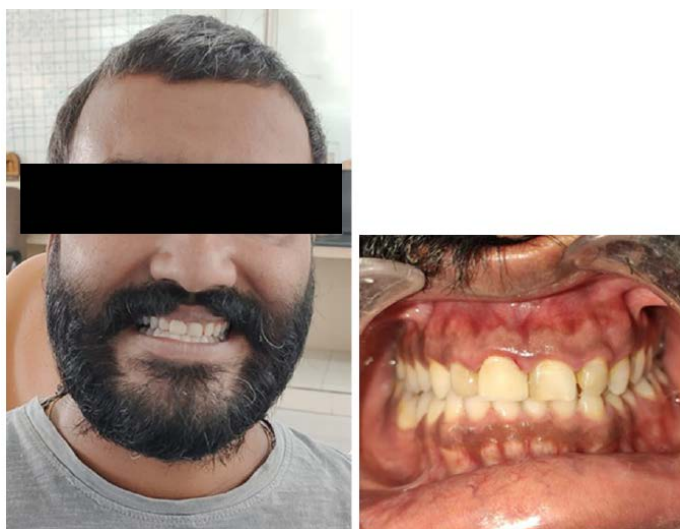
Figure 5: Post Operative Photograph
