**Retrieval of an osseointegrated fractured implant - A case**

**Type of Publication:** Case Report

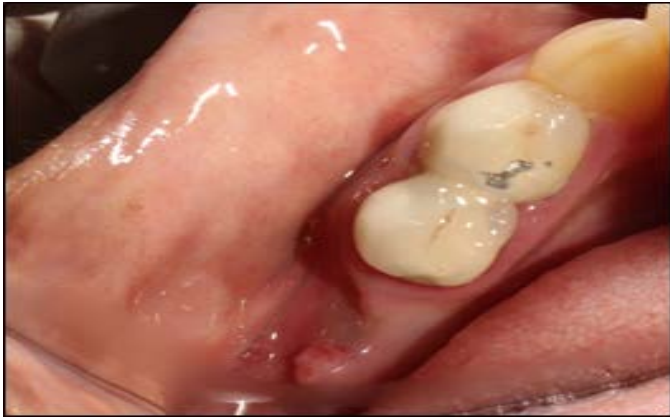
Figure 1

A 33 years old female reported to the department of Periodontology and Oral Implantology with pain and a swelling in the alveolar mucosa of the mandibular right molar region since the last 15-20 days (Figure 1). Upon further questioning the patient revealed that she had undergone surgical placement of dental implant in the same region followed by placement of implant supported prosthesis 5 years ago, but the prosthesis fractured and separated from the implant 1 year ago. The patient however ignored the issue and delayed reporting to a dentist which led to soft tissue overgrowth in that area. At the time of presentation, the alveolar mucosa in the region of tooth 46 showed presence of an abscess. The patient had no previous documentation and radiographs taken at the time of the initial procedure and was unaware of the implant system used.

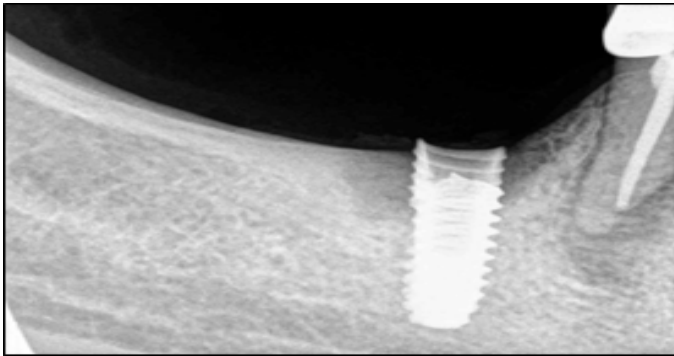
Figure 2

Radiographic examination showed a discernible fracture in the implant present in the region of 46. There was presence of typical saucer shaped bone loss around the coronal third of the implant extending up to the 5<sup>th</sup> thread (Figure 2). There was a periapical pathology present in tooth 45 which showed an obturation that was short of the apex and the part of the implant below the fracture appeared to be completely osseointegrated. A surgical removal of the implant was planned following necessary laboratory investigations. Pre-operative

The current case report represents a fracture of a commercially available pure titanium implant caused by a fatigue failure mechanism triggered by unfavorable loading conditions.

In this case, an increased vertical cantilever can be considered as a possible factor for the fracture of the implant. Due to absence of the periodontal ligament; as is present within natural teeth and the direct apposition to bone, the dental implant is restricted to move under loading to accommodate for occlusal forces. This usually results in excessive overloading leading to mechanical failures.

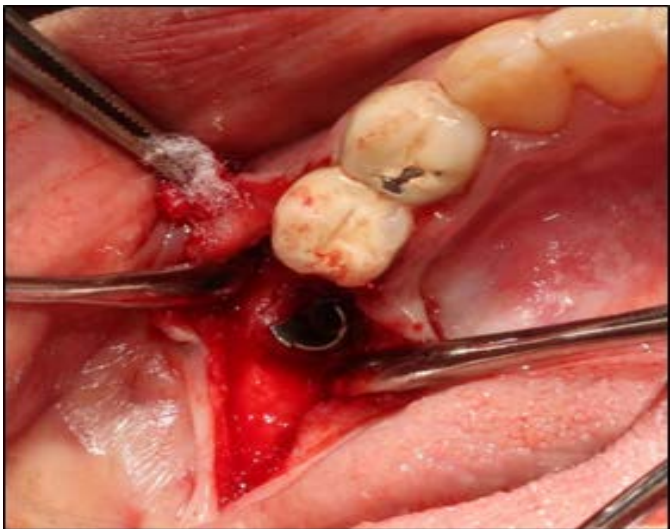
Figure 3

Supracrustal incision was given followed by reflection of a full thickness flap. The submerged part of the implant was exposed and the fractured rim of the implant was visualized (Figure 3). Guttering of the bone was carried out circumferentially around the implant using a piezoelectric device and a diamond coated flat metal insert (Figure 4). The implant was gradually loosened and removed with a luxator. A small fragment of the cancellous bone was also removed attached to the implant (Figure 5). The socket was cleaned with a surgical curette and irrigated with betadine and saline. The site was grafted with demineralized freeze-dried allograft and a collagen membrane (Perio Col<sup>TM</sup>) was used to cover the bone (Figure 6). The reflected tissue was sutured back using 4-0 silk sutures and patient was prescribed post operative medications; a combination analgesic of paracetamol and ibuprofen and antibiotic dosage of 500mg amoxicillin thrice daily for 5 days. (Figure 7).

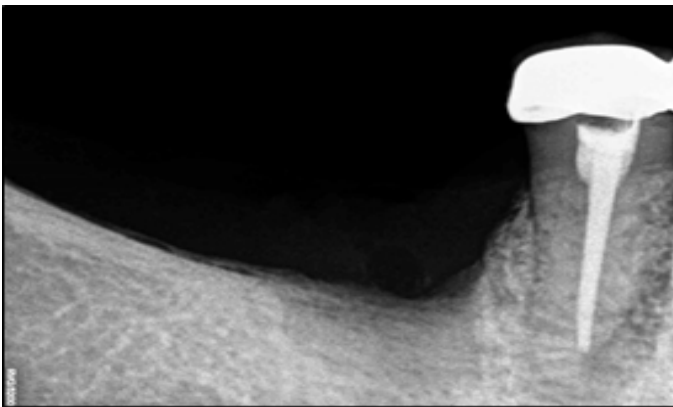
Figure 8

Sutures were removed 14 days after the procedure and uneventful healing of the site was noted. At the time of recall the patient presented with paraesthesia in the right quadrant extending from the corner of the lip till the angle of the mandible and the right lateral border of the tongue. A prescription of vitamin B complex tablets (Neurobion Forte) and multivitamin nutrition supplement capsules were given and patient was kept under periodic recall. 2 months post operatively the paraesthesia had reduced in span and persisted only in the premolar region but it had not completely reverted to normal. The 2 months postoperative radiograph shows bone fill in the socket and an otherwise uneventful healing was present (Figure 8). The patient was referred

to the endodontist for re- root canal treatment of 45and was kept under regular follow up.
