**Conservative aesthetic approach in reinforcing severely discoloured root-canal retreated permanent central incisors- A case report**

**Type of Publication:** Case Report

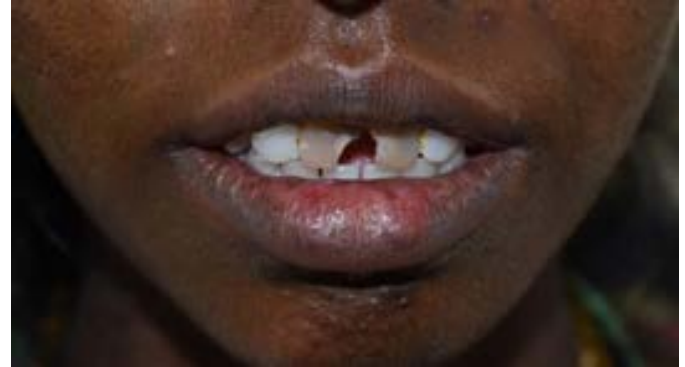
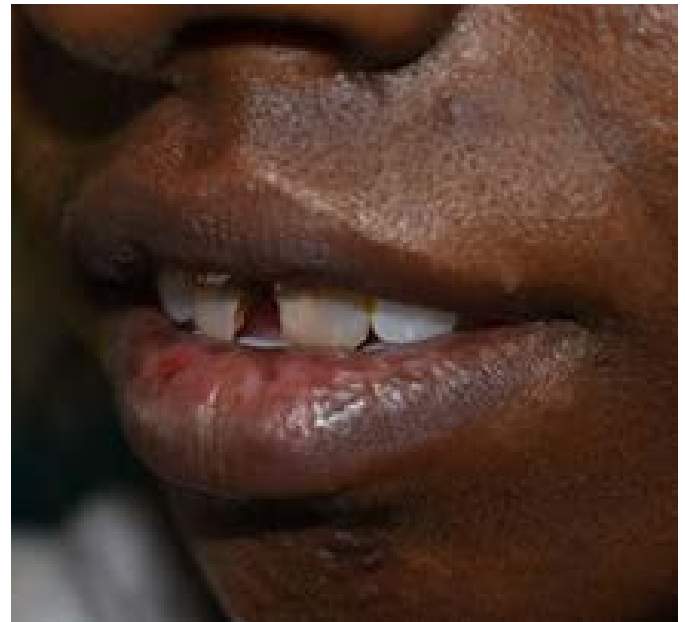
Figure 1: (a & b), images taken at 1<sup>st</sup> visit, extensively discoloured, carious central incisors.

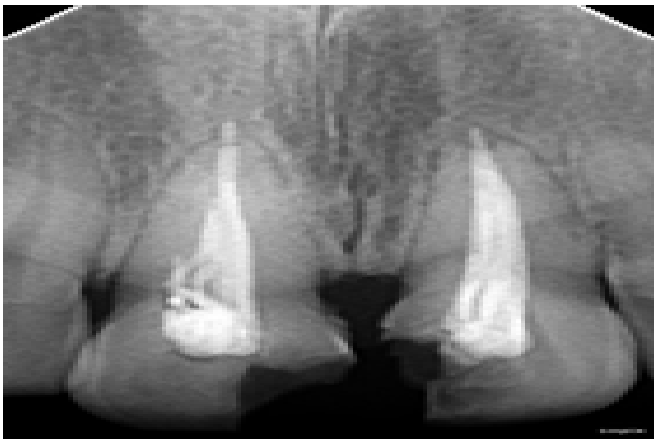
Radiographically, both teeth showed separated gutta-percha fragment that was seen displaced beyond the apex, widened PDL space and well-defined periapical radiolucency in #21 (fig. 2). The surrounding soft tissues were healthy with no lesions and was diagnosed as non-vital teeth with apical periodontitis in #11 and chronic periapical abscess in #21. Before starting the procedure, intraoral images were taken (fig. 3, a-e).

Figure 2: RVG reveals, improper obturation, with fractured gutta-percha fragment displaced beyond the apex, ledge was created in the cervical region with widened PDL space and well-defined radiolucency in tooth #21.

coronal seal, procedural errors, such as overfilling, underfilling, ledge, perforation, separation etc., affect the outcome of the endodontic therapy.<sup>12</sup> In the following case report, the previously treated root canal was overfilled, with a ledge created in middle third of the root #11. Longstanding dislodged coronal restoration, followed by development of secondary caries could have contributed to the failure of primary endodontic treatment.<sup>13, 14</sup>

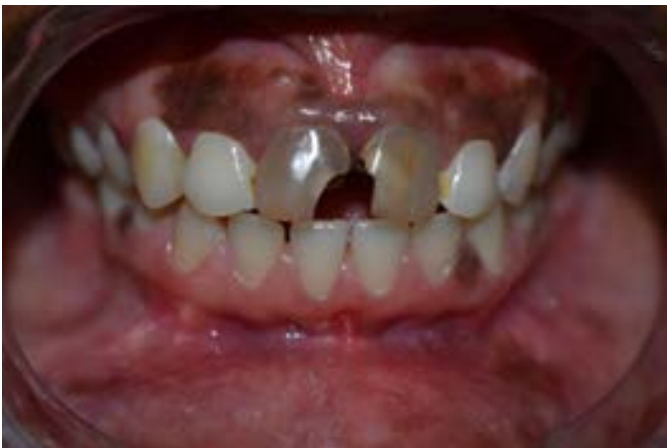
Figure 3: intra-oral images; front view.

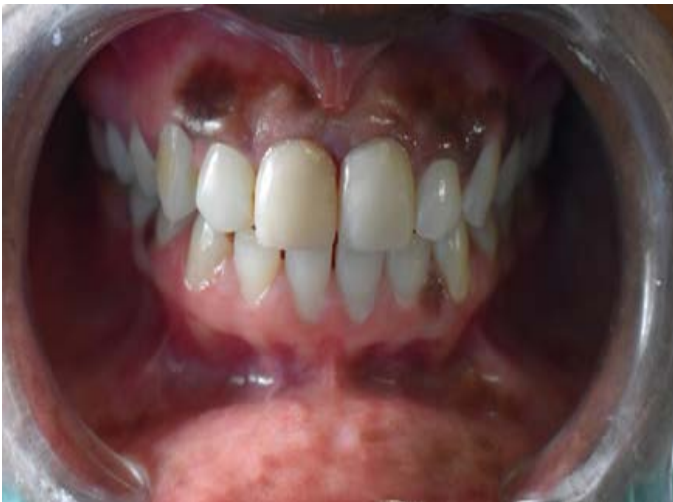
Figure 14: 12months follow-up image.

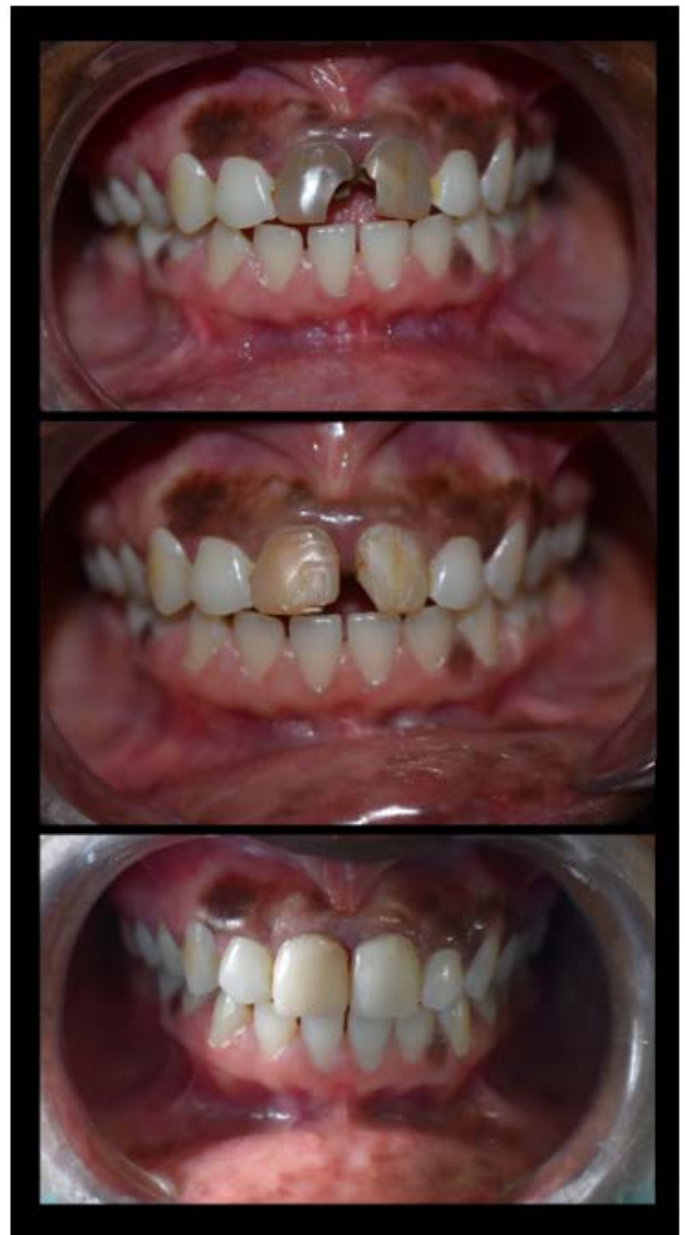
Figure 15: collage of images at 3 stages; 1<sup>st</sup> visit, after bleaching and 12months follow up image.

The fabricated composite veneers (Adoro Ivoclar) (fig. 12) were evaluated for the fit and shade in the patient's mouth. Bonding of the composite veneer was done under rubber dam isolation. Etching of the teeth surfaces were done as follows, etching of the residual enamel; and composite surfaces were done with 37% phosphoric acid for 15 seconds followed by application of universal bonding agent, dentine was conditioned with two layers universal adhesive (Prime and Bond universal, Dentsply), and silane coupling agent was applied on the surface of the composite resin. Intaglio surface of composite resin was etched with 5% hydrofluoric acid, for 10 seconds, followed for application of silane coupling agent. The composite veneers were cemented on the tooth surface using dual-cure resin cement (variolink, Ivoclar Vivadent), gross excess cement was removed and light cured for 40 seconds. Polishing of the veneers were done 24hrs after the cementation of the veneer, radiographs were obtained (fig. 13 a-c), and the patient was followed for a year (fig.14). Fig.15 represents changes in the aesthetics of the patients at three different intervals i.e., first visit, after non-vital

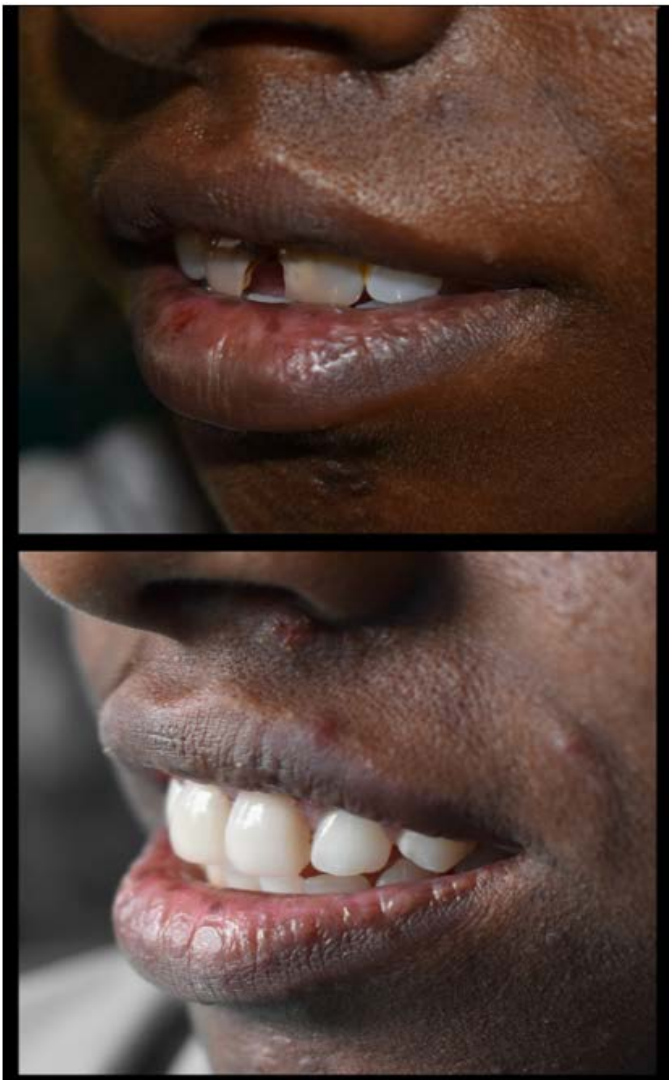
Figure 16: Collage of patient profile, before and after treatment.

bleaching and 12months follow-up. Fig.16 represents change in patient profile after the cementation of the indirect composite veneer at 12-months follow-up period.
