Management of complicated anterior maxillary crown root fracture with everstick post rehab & zirconia crown - with 1 year follow up

Type of Publication: Case Report

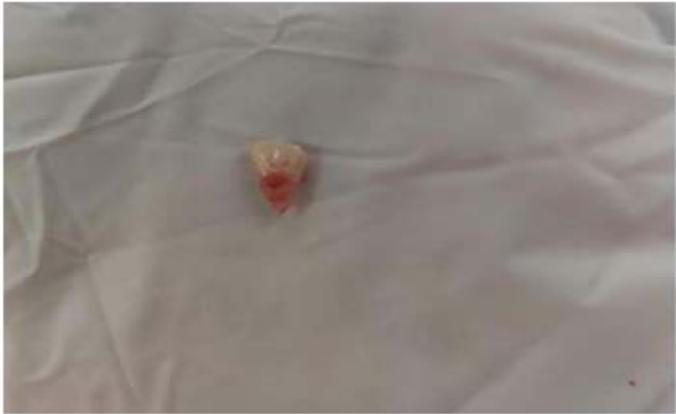
Figure 2: Extracted Lingual Tooth Fragment 13

& crack lines on root surface of 12, 13. A palatal fragment of 12 was removed as it was mobile & de attached from sub gingival area. Vitality of 11 was checked again which revealed vital status.

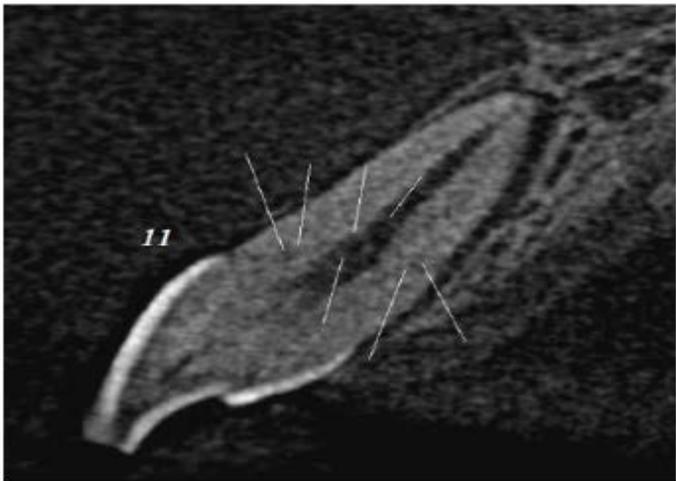
Figure 3: CBCT Showing Fracture Line

A written consent was obtained from patient & family. Local anesthesia was administered. Reduced mouth opening, swelling & extreme exaggerating pain adds challenges to perform endodontic treatment. H file was used to extirpate all the pulp tissue. Step back technique of bio mechanical preparation was done. The patient was recalled after a week. Obturation was done using lateral compaction method. CBCT report revealed multiple craze

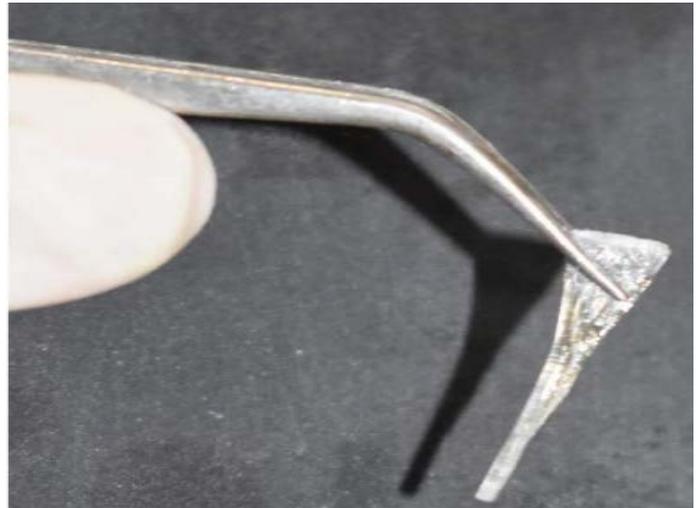
Figure 5: Manipulated Everstick

Patient was recalled after a week. Oral prophylaxis was carried out. Everstick post was decided to be used for 13 as it requires minimal root canal preparation & there were already cracks present on root surface which we didn't wanted to propagate. Gutta percha was removed with a peeso reamer no 2 without enlarging the canal leaving 5mm of gutta percha apically. Canal was rinsed with saline & dried with paper points. Estimation was done of total height of tooth including coronal structure. Everstick post of 0.9 diameter was removed from foil bag. Required post length was cut with scissor & the foil was closed. Post was inserted into canal with tweezers & fit was checked at length 20 mm. It was taken out & light cured for 10 seconds. Further the canal was coated with resin cement with an applicator tip & Everstick post was inserted slowly. Coronal part of post showed fan shaped appearance which acted as core. Once properly fit it was light cured for 40 seconds. Further, 13 was etched, bonding agent was applied & composite core build up was carried out.

Everstick post is resin impregnated, uncured glass fiber having an inter-penetrating polymer network that can be cured to anatomic shape of crown. This resin impregnated unpolymerized glass fiber adapts to root canal morphology which doesn't leave any void & empty space providing good support to core. The glass fiber can be reactivated even after polymerization leading to desired shape of tooth crown. Thus the stress is distributed evenly across the root surface & reduces the chance of root

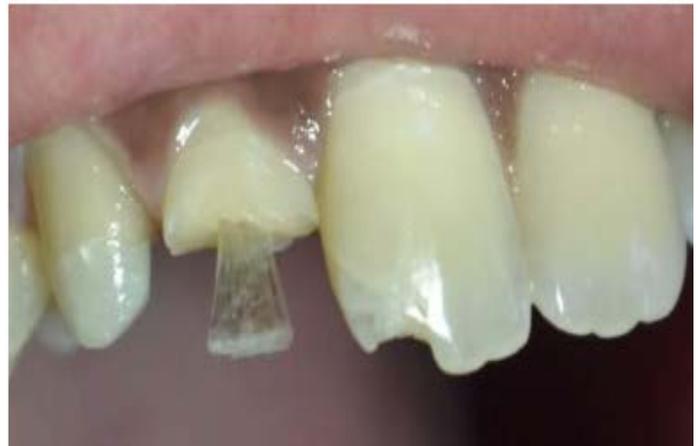
Figure 6: Everstick Placed

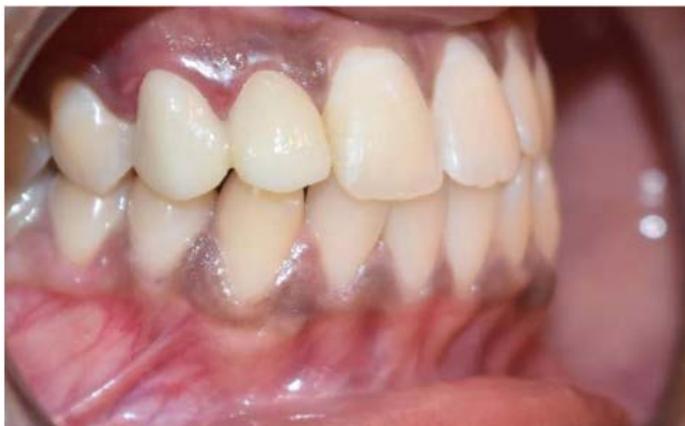
Figure 7: Post Op

As the patient had esthetic concern, instead of composite restoration zirconia dioxide crown were decided. Crown preparation was done & impression were recorded. Temporary acrylic crowns were given on very same day for esthetic purpose. Zirconia crowns were delivered after a week. The patient was happy with the form & function of tooth. Also there was no change in pulp status of 11 even after 5 weeks, though a 1 year follow was carried out which revealed the same. There was no crack propagation in root surface or crown dislodgement after 1 year.

Zirconia crowns were placed taking into account patients desire & physiologic needs such as form & function. Zirconia crowns have exceptional physical & biologic properties. It also provide high strength along with better esthetics & are corrosion resistant. Also it has high wear resistance & marginal accuracy with internal fit. The patient was happy & satisfied with the treatment provided & had a 1 year follow up with regular intermittent visits. He had no complaint about esthetics neither function of tooth.
