Prognosis of a Polished Surface Basal Implant

Type of Publication: Case Report

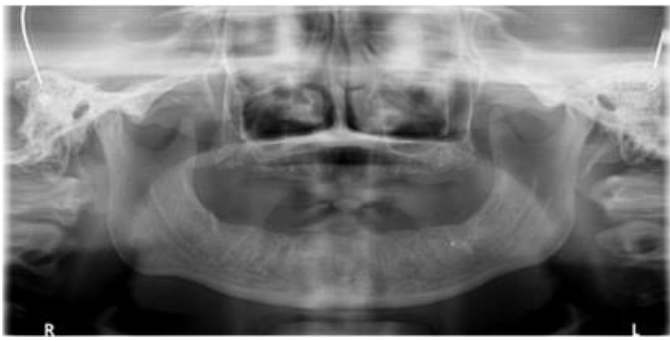
Figure 1

1. Image showing preoperative OPG
2. Preoperative CBCT image
3. Implant placed far away from the root piece
4. CBCT image of the lesion
5. Clinical Picture of the lesion
6. CBCT image after extraction
7. Follow up Radio graph.
