Conservative esthetic management of post orthodontic treatment discolored tooth with calcified canalMuhammad Qasim Javed¹ (FCPS), Sumyya Saleh² BDS, Hamza Ulfat² BDS, Shaikh Shoeb Yakub³¹Assistant Professor, Department of Conservative Dental Sciences and Endodontics, Qassim University, Saudi Arabia.²Postgraduate Resident, Department of Operative Dentistry, Riphah International University, Pakistan³Associate Professor, Department of Conservative Dental Sciences and Endodontics, Qassim University, Saudi Arabia.**Corresponding Author:** Dr Muhammad Qasim Javed, Assistant Professor, Department of Conservative Dental Sciences and Endodontics, Qassim University, Saudi Arabia**Type of Publication:** Case Report**Conflicts of Interest:** Nil**Abstract**

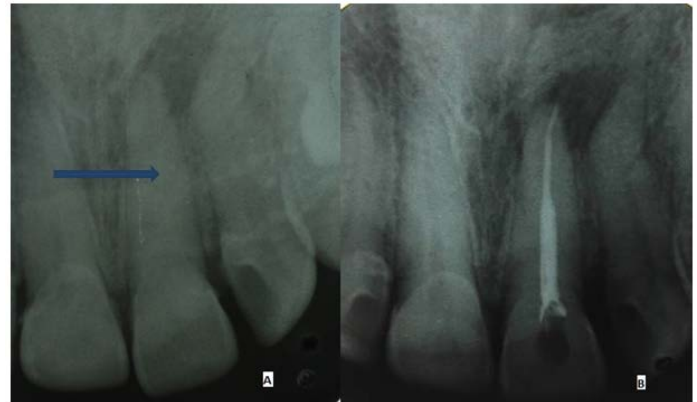
Figure 1: Periapical radiographs of Maxillary right central incisor (A) Preoperative: Calcified canal (Blue Arrow) (B) Obturation

incisor. Patient gave the history of malaligned Maxillary right central incisor and subsequent orthodontic treatment that was finished two years ago. The response to vitality tests was negative. On percussion and palpation test, patient reported mild pain. Digital periapical radiograph revealed right maxillary central incisor with obliterated canal and diffuse periapical radiolucency (Figure- 1A). The tooth had yellowish grey crown (Figure- 2A). Periodontal pocket depth was normal. A diagnosis of pulp necrosis and calcific metamorphosis was reached. After giving anesthesia and isolation, an endodontic access cavity was prepared at upper right central incisor with number 2 round diamond bur (Mani, Inc. Japan). The slit of the pulp chamber become visible and calcification was removed by using ultrasonic tip. Canal orifice was located with the help of endodontic explorer (DG-17). Patency of the canal was achieved with 08 K-hand file (Mani, Inc. Japan). The working length was measured with the radiographic method. After preparation of glide path canal was cleaned and shaped to size 30/.04 by using Hyflex[®] CM file system (Coltene). Irrigation was done by utilizing 3% sodium hypochlorite (Septodont) and EDTA 15% (Septodont), alternatively, with rinse of saline in between. 27 gauge closed end side vent needle was used for irrigation. The canal was dried with sterile paper points. Obturation was done with Gutta Percha (GP) points and calcium hydroxide based sealer (Sealapex, Sybron Endo) by using cold lateral condensation technique (Figure-1B). Subsequently, GP was removed 2-3mm apical to canal orifice and restorative glass ionomer cement (GIC) was applied on the obturating material to minimize leakage of bleaching agent. After placing rubber dam 35% hydrogen peroxide (Opalescence[®] Endo[®] Ultradent gel) was injected into the chamber followed by the placement of cotton pellet and sealing of access cavity with restorative GIC (Vitremer, 3M). The process was

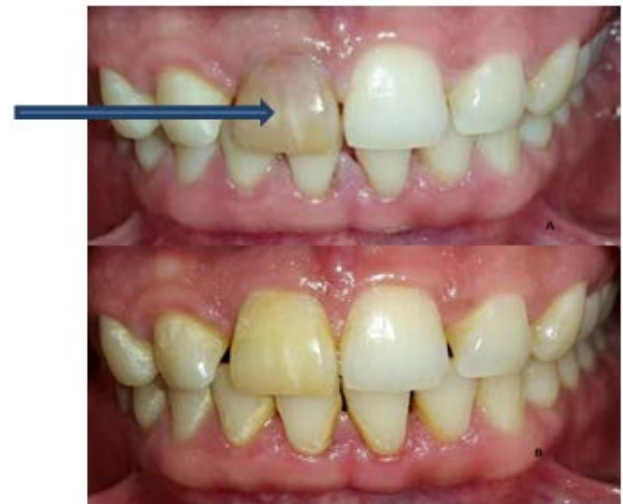
Figure 2: (A) Preoperative picture with discolored tooth (blue arrow) (B) Postoperative picture

repeated three time after the interval of five days. Desired results were achieved after the third visit and patient was satisfied (Figure-2B). Subsequently, the tooth was permanently restored with resin composite after 7 to 10 days.
